## Atlantic Shore Line Railway Steeple Cab Locomotive 100

### Curatorial Report 18

21 April – 7 October 2009

by Donald G. Curry, Shop Manager

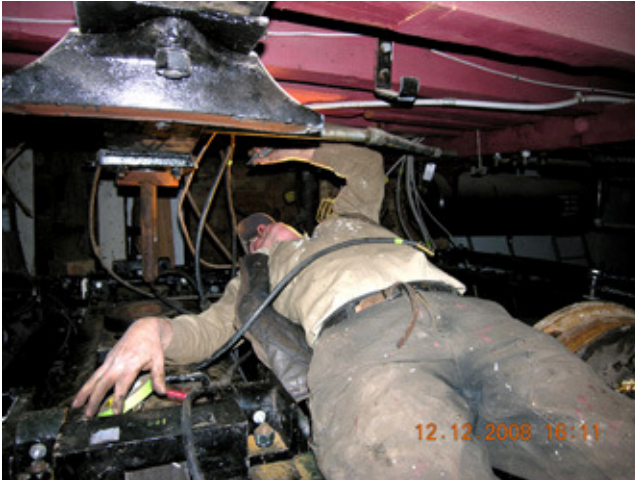
The connectors are the set-screw type as originally used. However, because of the extreme corrosion we found on the originals we replaced the steel screws with stainless. (10-24 x  $\frac{3}{8}$  in. round-head machine) The original connexions were insulated in various ways but most commonly with cambric tape covered with layers of friction tape. For ease of access in case of problems, we chose to use standard insulated 'loom' tubing, secured on each end with vinyl tape.<sup>16</sup>

Installing the motor lead connectors. (Isn't there an easier way!?)

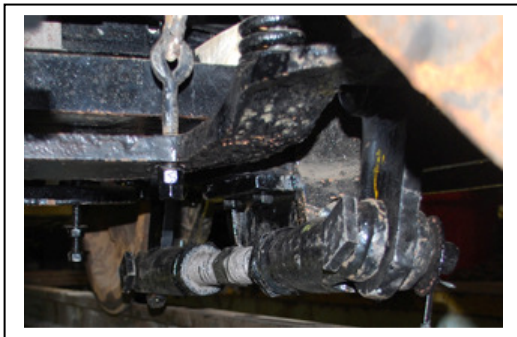
Low hanging slack adjuster and that's just the running rail

- Slack adjusters (two per truck between each set of wheels) Rubbed on top of the guard rails. **Dean Look** was able to adjust the supportive linkage as well as cut off the ends of several of the brake levers to reduce the interference to the point that they barely touch the rail, simply sliding along the top.<sup>20</sup>

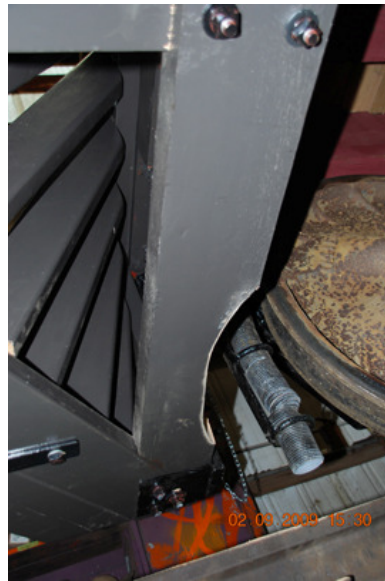
- The sander hoses<sup>19</sup> jammed between the wheel and the inner cross beam of the pilots. The beams had to have a long notch cut out using a Tiger saw.

Cut-away area under pilot brace to clear the sander

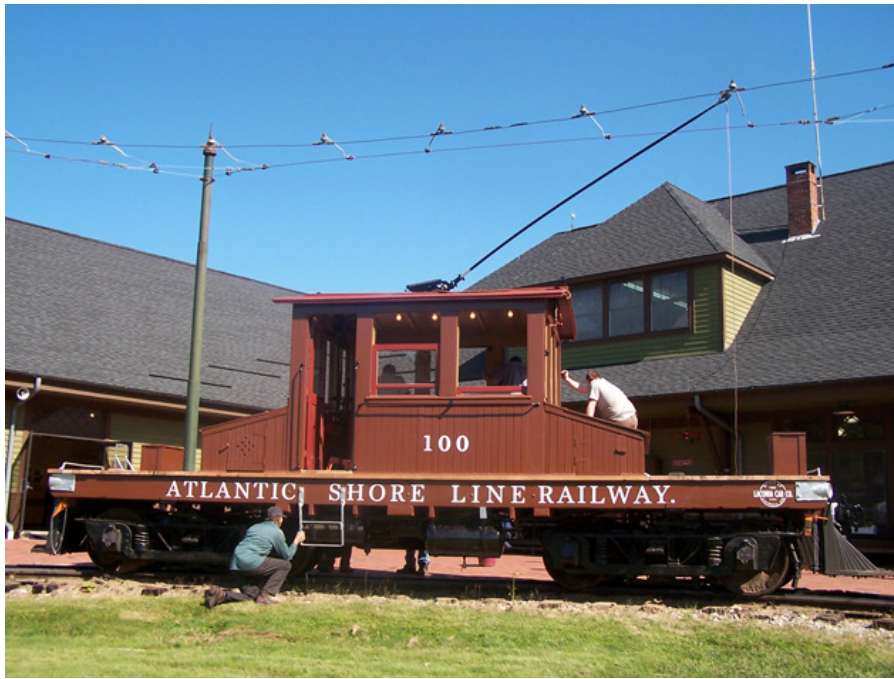
Interferences found and corrected (some requiring a second treatment to get full clearance):

Dean checking for interferences

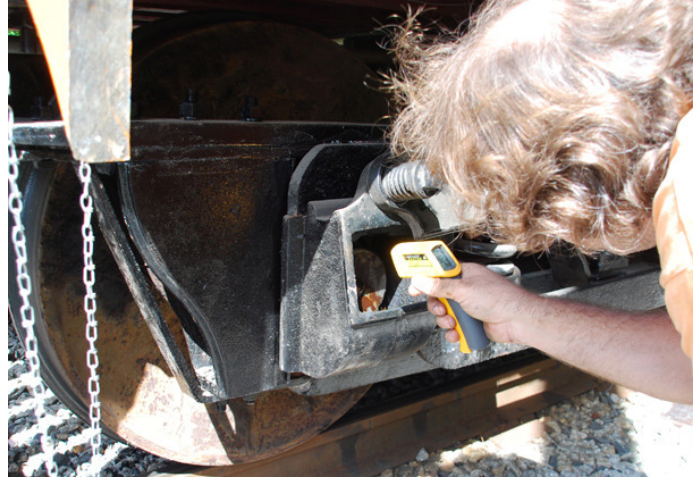
One of the purposes of the run was to see if there were any tight bearings. **Randy** felt each bearing and discovered one journal bearing (no. 2 R) had become uncomfortably warm. The next day he removed that bearing and found the surface had galled. Using a babbitt scraper, he removed the high spots which had caused uneven contact as well as heating also due to inadequate lubrication. Another trip was made shortly thereafter. This time, using the infra-red temperature sensor on each bearing, he

determined that the 'hot' bearing, which he had scraped was about 104° F. or just warm to the touch- Much improvement. The temperature range of the all other bearings was 88-100° F. - satisfactory.<sup>23</sup>

Randy taking temperature of the journal bearing that had overheated on a previous trip
