## Atlantic Shore Line Railway Steeple Cab Locomotive 100

### Curatorial Report 18

21 April – 7 October 2009

by Donald G. Curry, Shop Manager

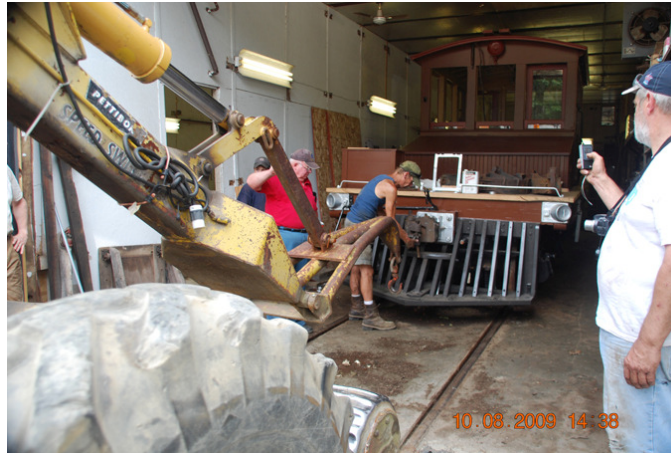
Phil Morse and his ubiquitous 'flip camera' recording for YouTube, Jack Coyle's connecting 100 to the *Pettibone* while Dick Avy prepares to give the 'go-ahead' signal.

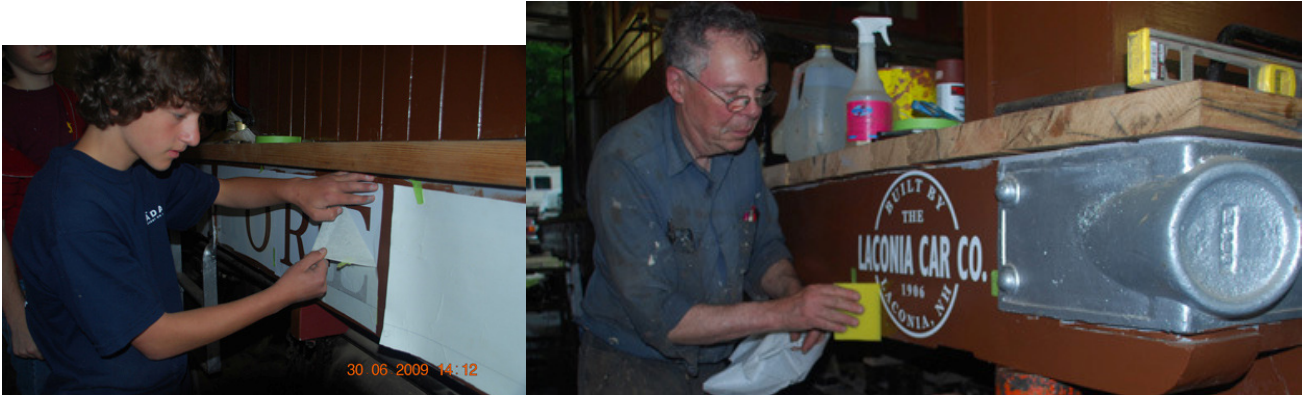
Antonio Steffon removing the masking from the side lettering  
Donald Curry “squeegeeing” the Laconia Car Company Logo

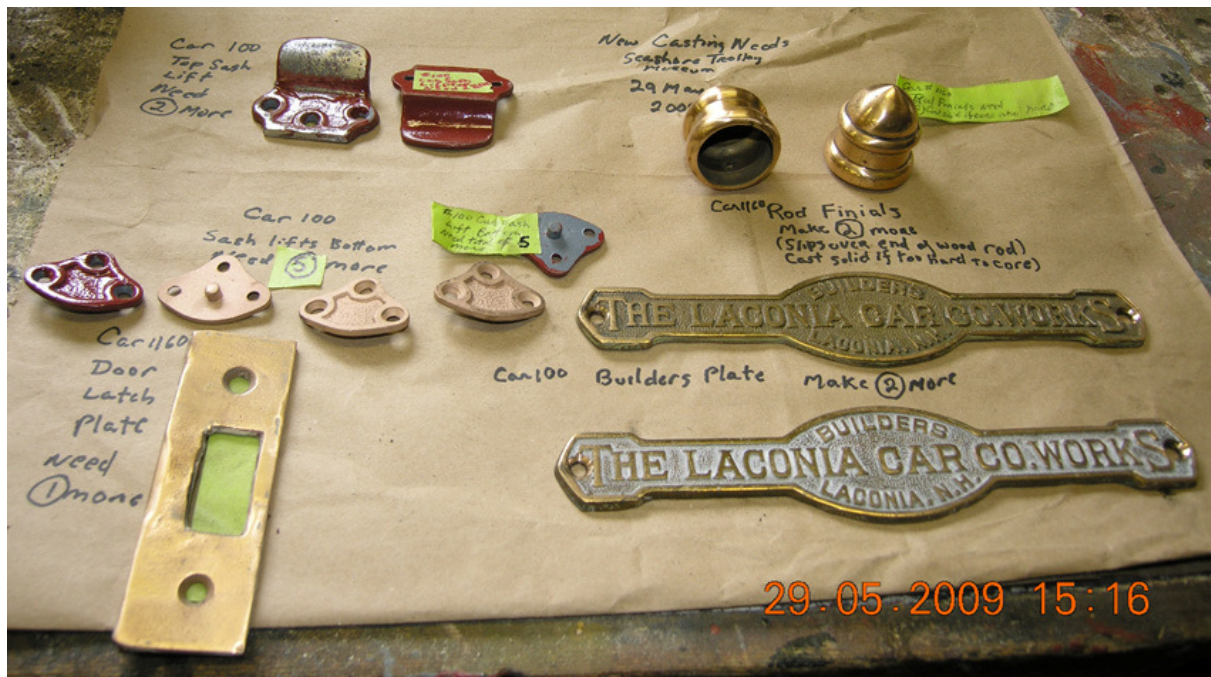
Castings we're still waiting for (including some for 1160)

Remaining castings – The Brass Foundry does excellent work but delivery is always a problem. Currently for 100 we are waiting for 5 sash lift bottom castings, 2 top lifts and two Laconia builders castings. The latter are for presentation to donors. After the castings come, new leather sash lifts can be made. Cost for the castings is \$405.

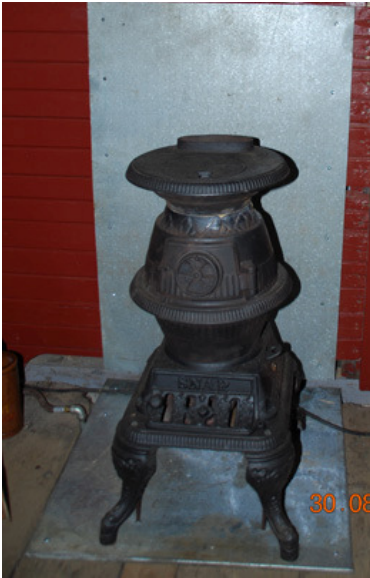
The stove  
before  
installing the  
smoke pipe

**The stove** – The little pot-bellied stove is now securely fastened down in the cab. **Phil Morse** cleaned it up and installed the special bolts which keep it from tipping over. Under it and behind it is a galvanized steel sheet spaced away from the wall and floor to allow air to circulate. Although we don't intend to use it (for fire safety reasons), it does look real. Haley's Metal Shop fabricated a stove pipe and 'chinamens' hat stove pipe which appears to go through the roof but actually doesn't.
